Beaverdam Run Condominium Association

**Long-Range Plan for the Capital Fund – 2010
September 21, 2009**

To: BRCA Board
From: The Long-Range Planning Committee¹
Date: September 21, 2009
Subject: The 2010 Capital Reserve Fund Long-Range Plan

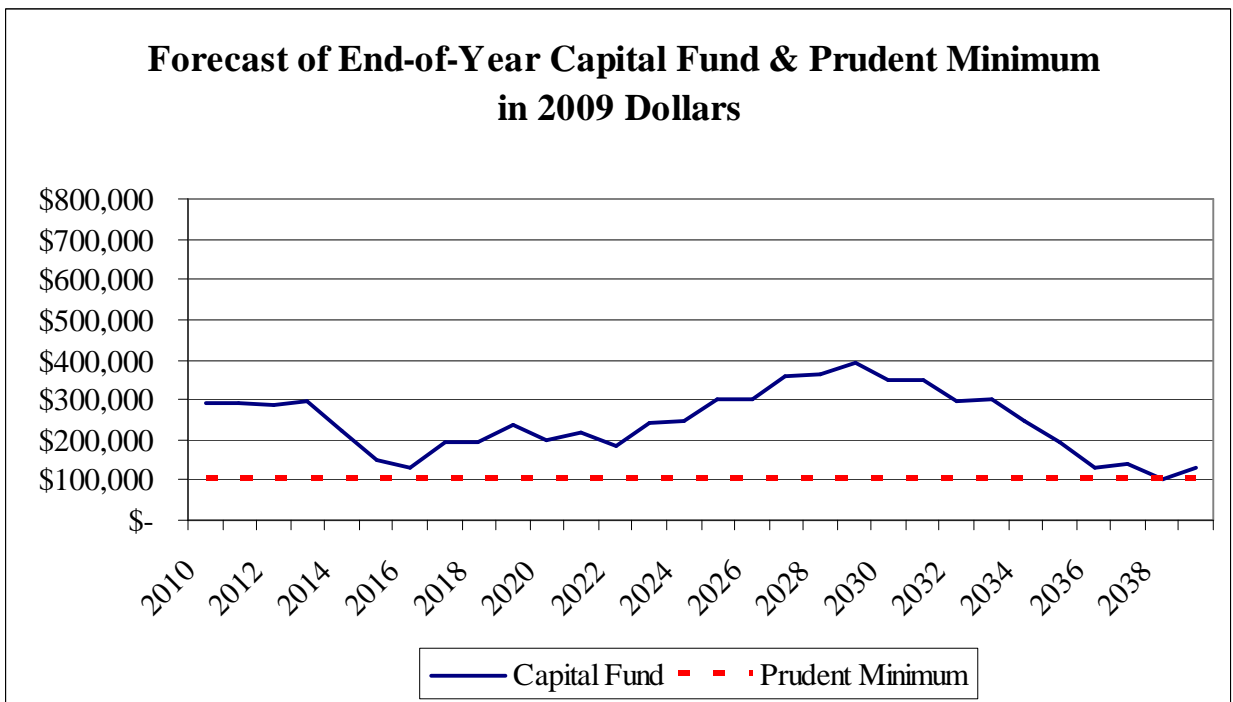
Our incorporating inflation into our forecasts might give some readers the mistaken impression that the Condominium will be accumulating vast resources. To avoid such an impression, Figure 3 presents the same data as in Figure 2 but removing the effects of inflation; thus, the figure below expresses the forecasts in 2009 dollars.

Over the next 30 years, we forecast that the Capital Fund will range between \$102,000 and \$392,000 in 2009 dollars. The forecasted average level of the fund is \$245,000 in 2009 dollars.

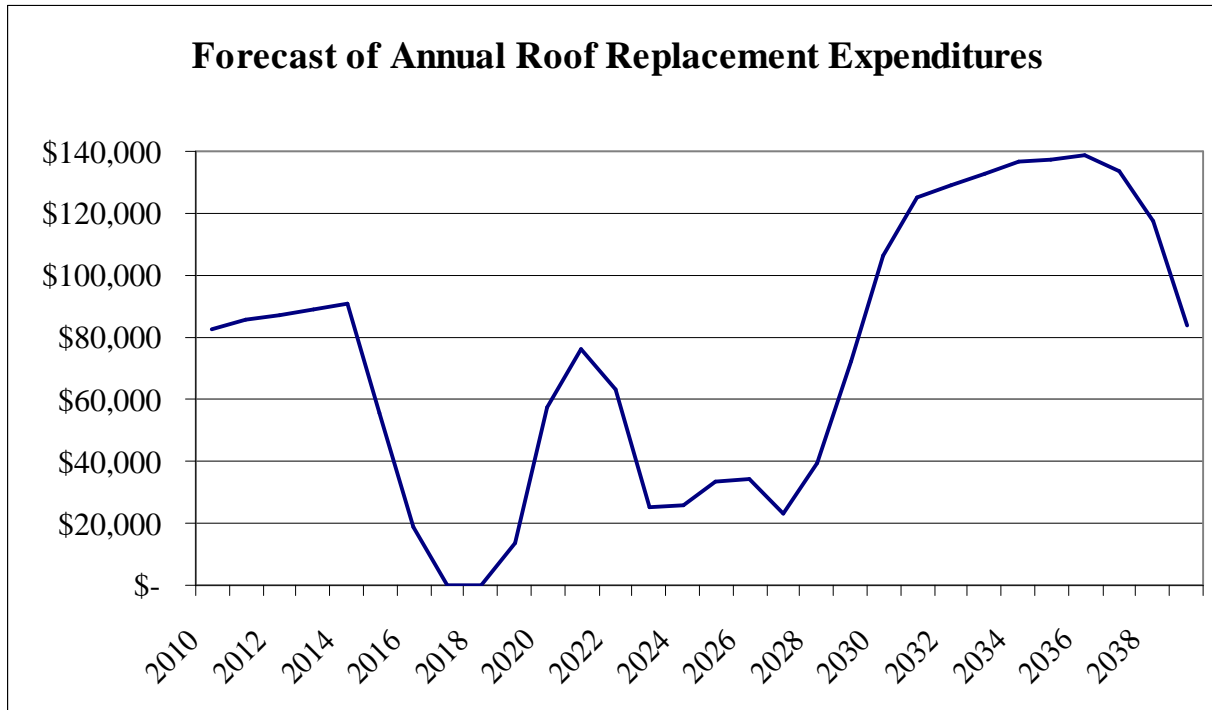
The forecast of expenditures to reroof Units, the Clubhouse, and the Log Cabin is shown in Figure 3.1 below:

replacements shown in Figure 3.1 above are derived by multiplying the counts of Unit roof replacements in Figure 3.6 by the cost per Unit, which increases over time by the rate of inflation.

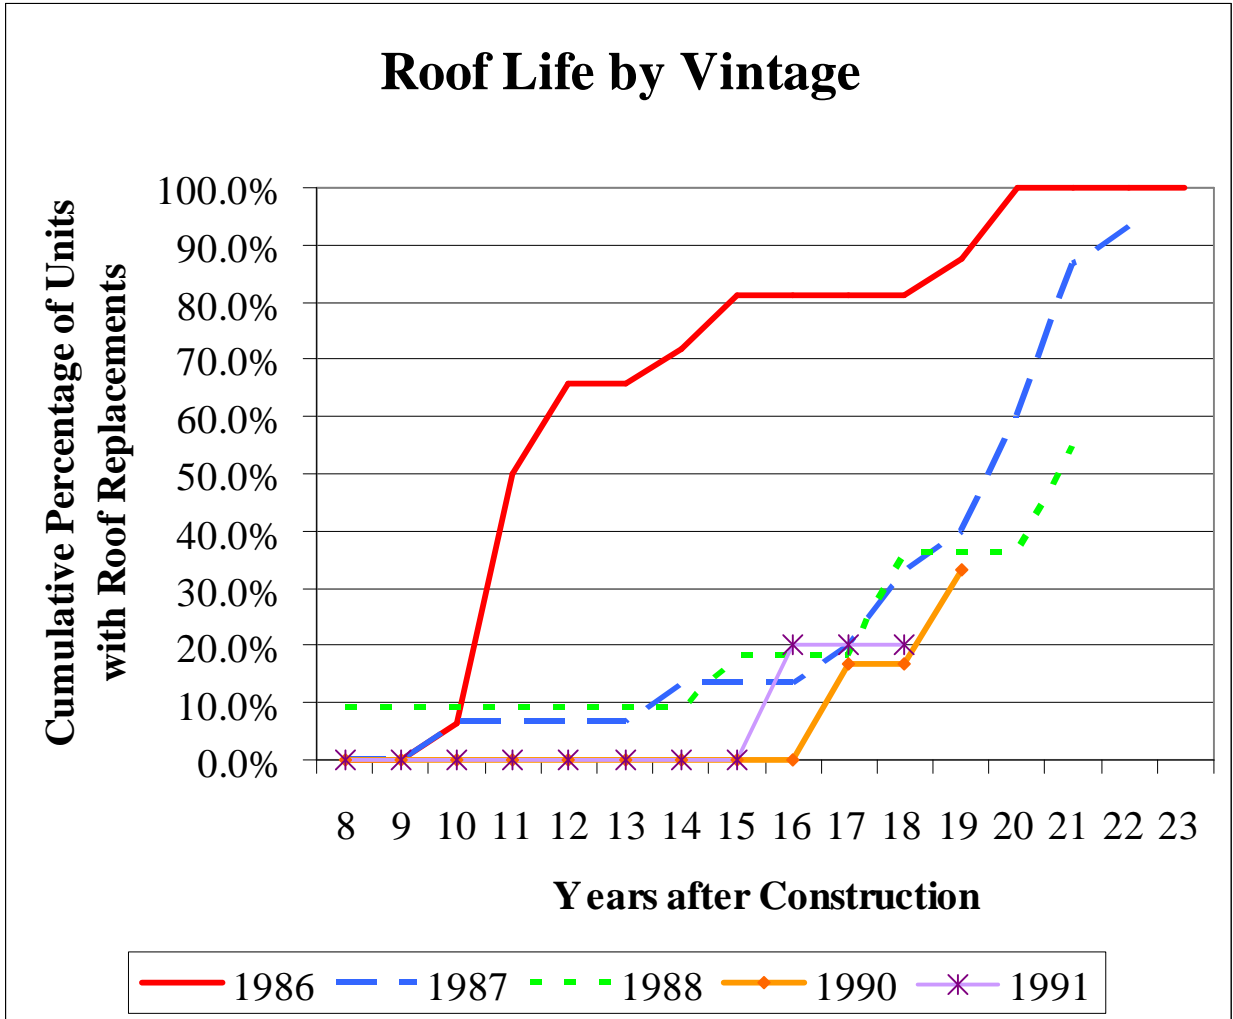
Figure 3.4

We assume that other Unit vintages after 1988 will have a replacement pattern similar to that of the 1987 vintage, with an average life of 19 years. The sparse data for vintages 1990 and 1991 provides weak support for this assumption; see Figure 3.4.

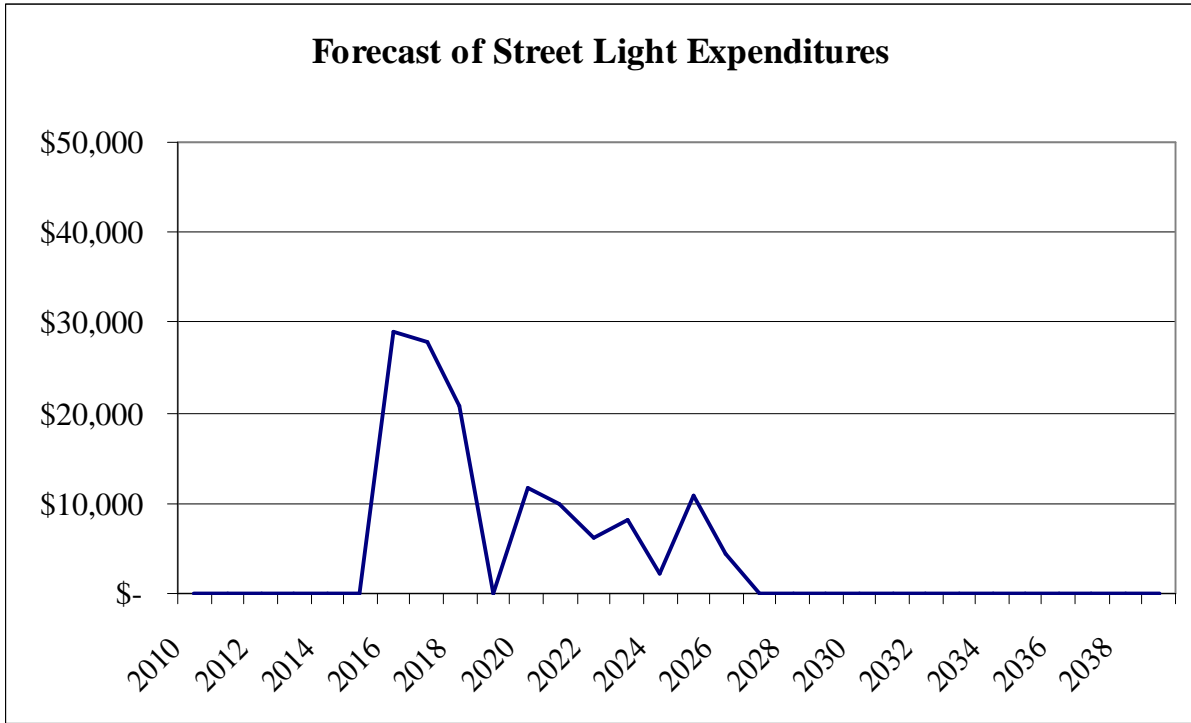
Figure 6.1 shows our forecast of expenditures on replacing streetlight poles and fixtures for the next 30 years. The maximum annual expenditures on replacing the items in previous sections – roofs, roads, and the pool enclosure – are far larger than the maximum annual expenditures on all but one of the remaining items. Therefore, we show the graph for the previous items on a scale from \$0 to \$140,000, while that for street lights and the remaining items in this report on a scale from \$0 to \$50,000.

BRCA’s wooden streetlight poles eventually will have to be replaced. Although they do not reveal any below-ground rot, some of them are beginning to crack above ground. In addition, the Condominium has recently had to repair several of the light fixtures. We assume that the expected life of the streetlight poles and fixtures is 30 years from when they were installed. We lack data on when the street lights were installed, so we assume that the number of street lights installed each year was proportional to the number of Units built each year. We assume that the Condominium will undertake a multi-year replacement program beginning in 2016 (the first construction year 1986 plus 30 years of pole life). We forecast the expenditures based on this replacement program.

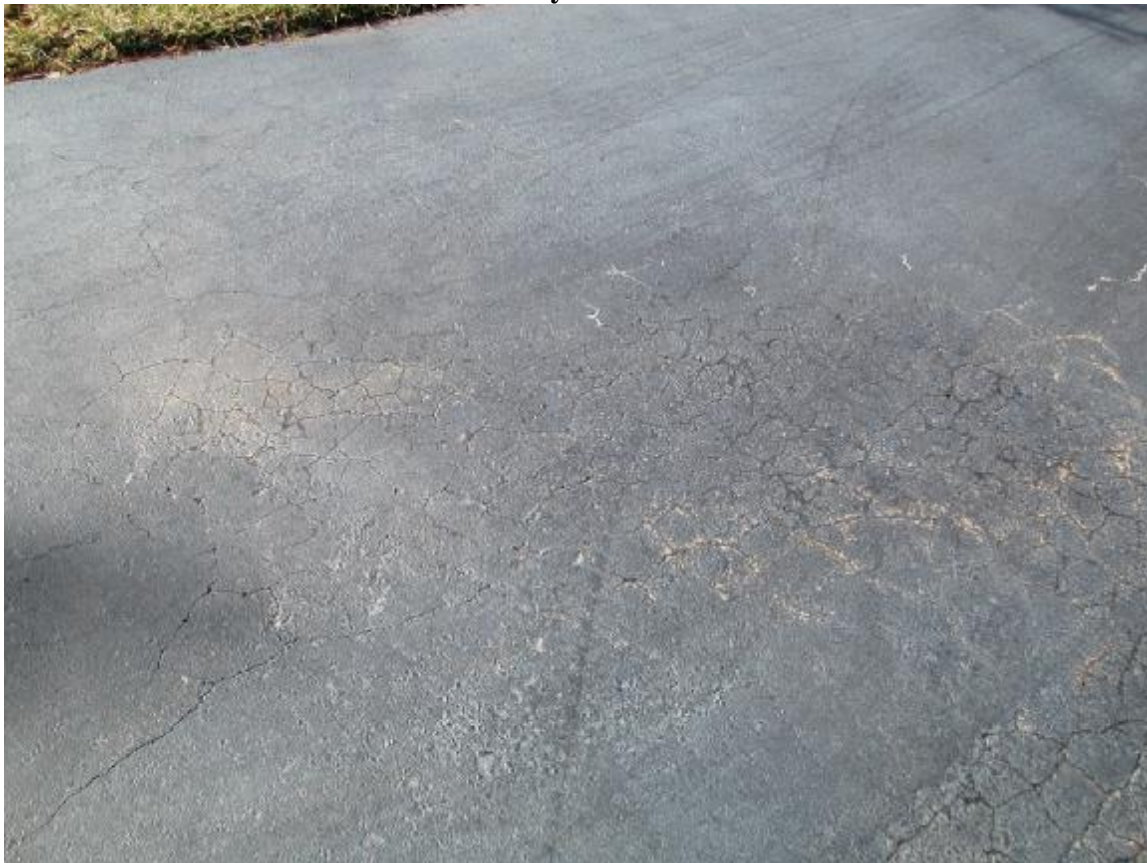
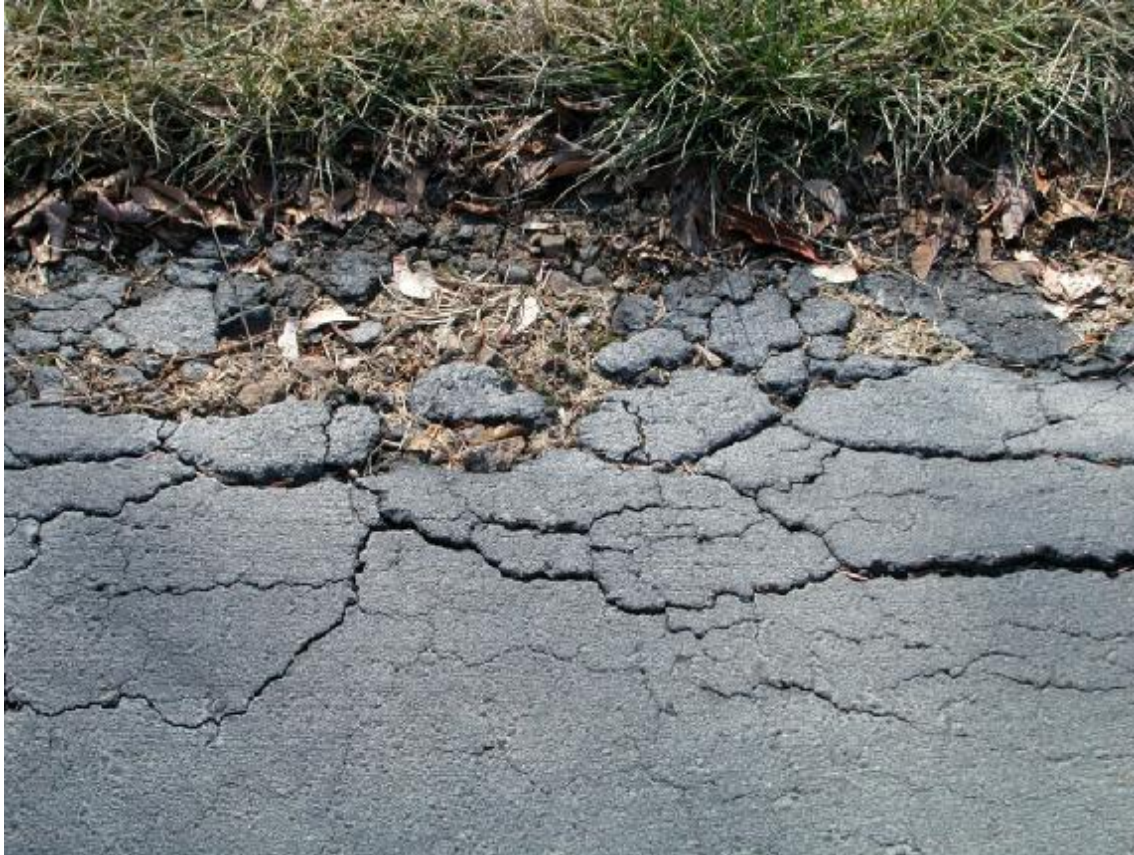
When a driveway should be repaved is a matter of judgment. Influences on such a decision are safety, protection of the driveway and its base from the freeze-thaw cycle, and aesthetics. As discussed in Section 4.2, the timing should also be influenced by when the road is repaved at the end of the driveway. Based on our observation that several driveways have extensive crazing (also called honeycombing or alligatoring), large cracks, and crumbling, we conclude that the BRCA has tolerated poor condition of driveways. Figures 7.2 and 7.3 show examples of driveways that are in poor condition.

Figure 7.2
Driveway in Poor Condition

**Figure 7.3
Driveway in Poor Condition**

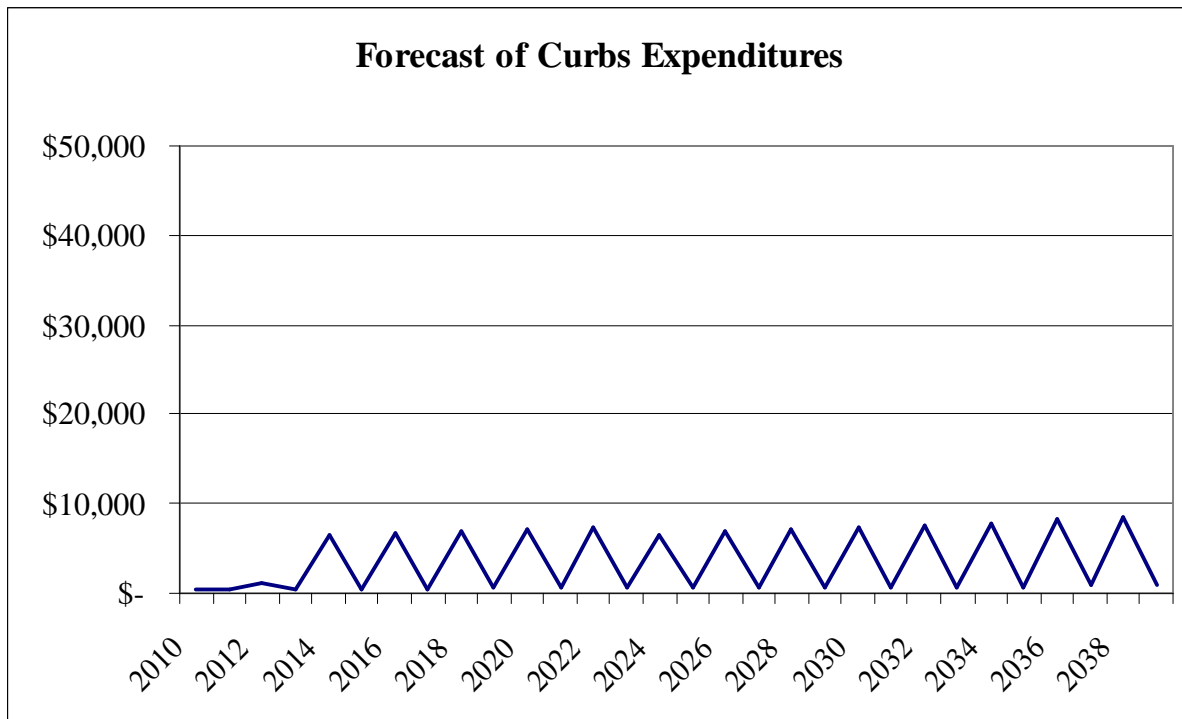
Figure 8.1 shows our forecast of expenditures on replacing curbs along the Condominium’s roads for the next 30 years.

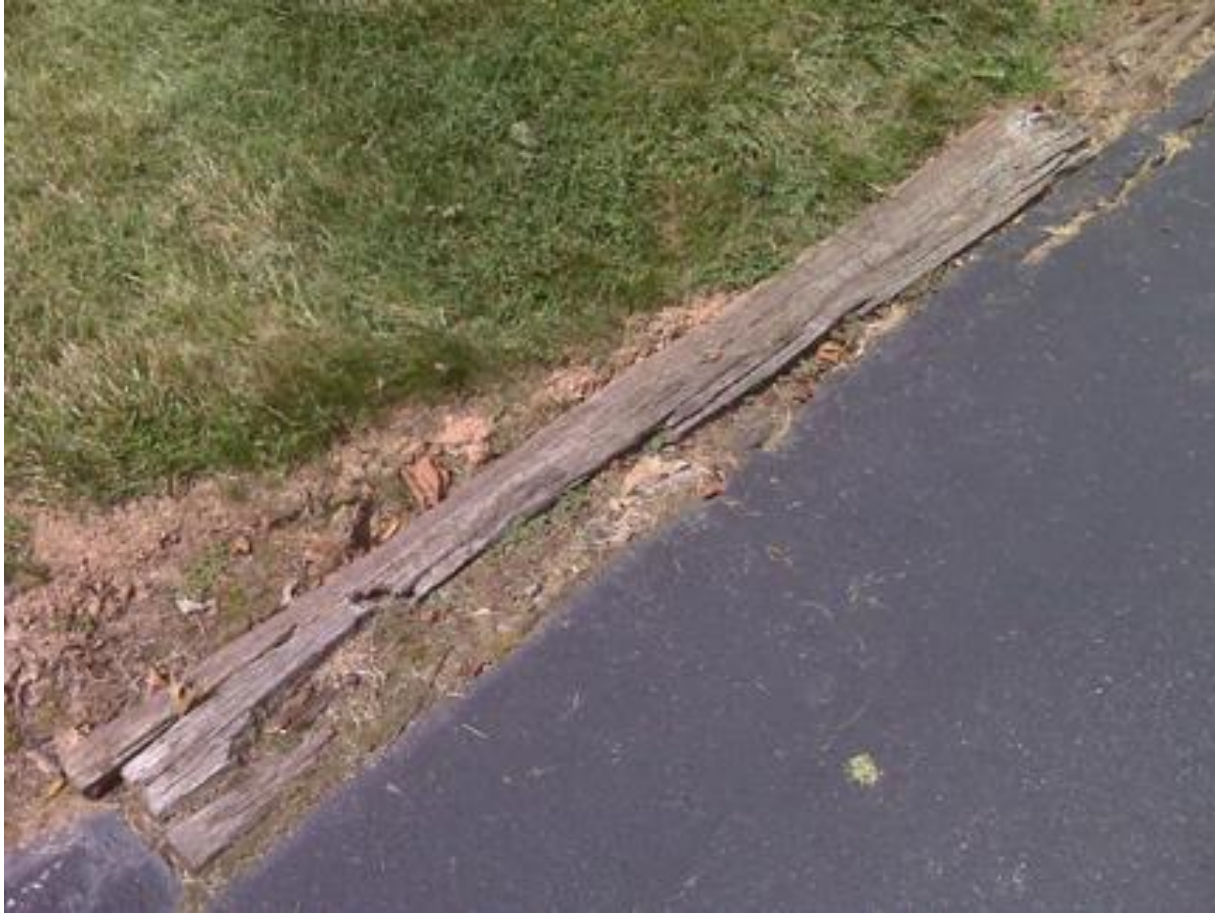
Figure 8.3 shows an example of a railroad tie curb that is very poor condition.

Figure 8.3
Curb in Very Poor Condition

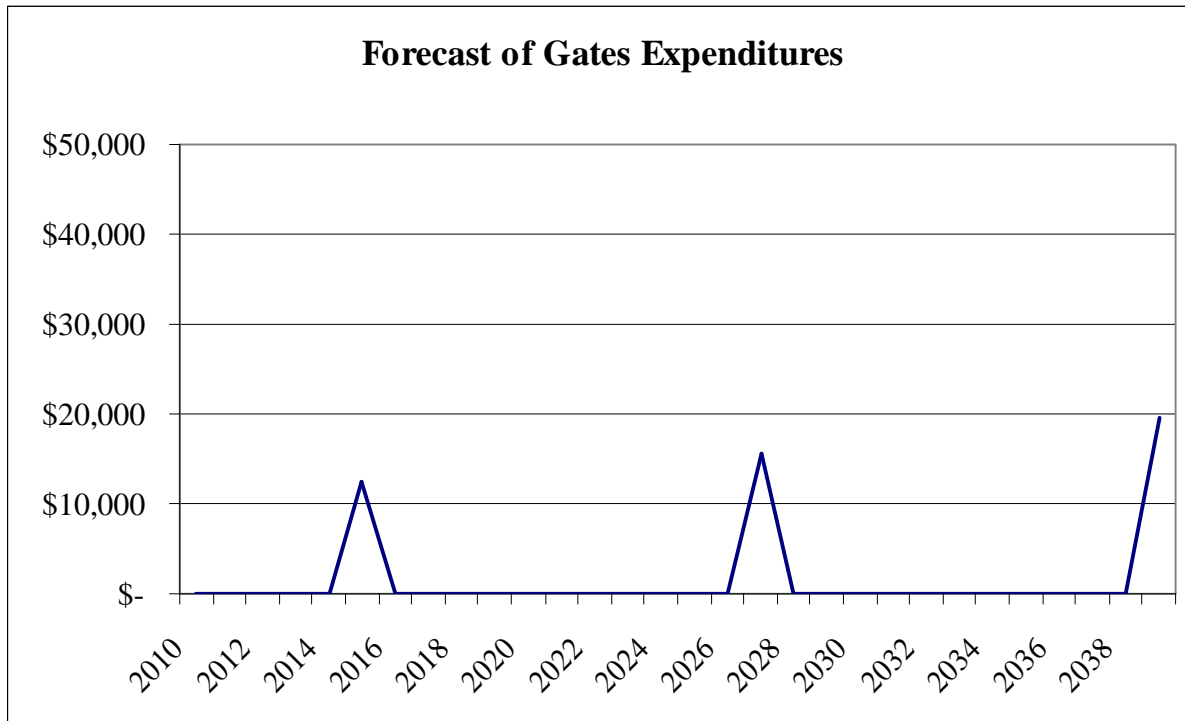
Figure 11.1 shows our forecast of expenditures on replacing the entrance and exit gates for the next 30 years.

In November 2003, BRCA's main entrance and exit gates were replaced at a cost of \$9,586³⁴. We assume that today's cost of such a replacement would be higher by the cumulative amount of inflation that has occurred since then – 16 percent – and expenditures on each subsequent replacement will rise at a rate equal to the future rate of inflation. We assume that the original gates were installed in 1991 and that those original gates were what were replaced in 2003. Thus, we assume the lifetime of the original gates was twelve years. Consequently, we assume that the existing gates and all subsequent replacements will also have a life of twelve years. Based on those assumptions, the next gate replacement will occur in 2015 and will cost \$12,448. We have not developed a forecast of expenditures on replacing the service gate.

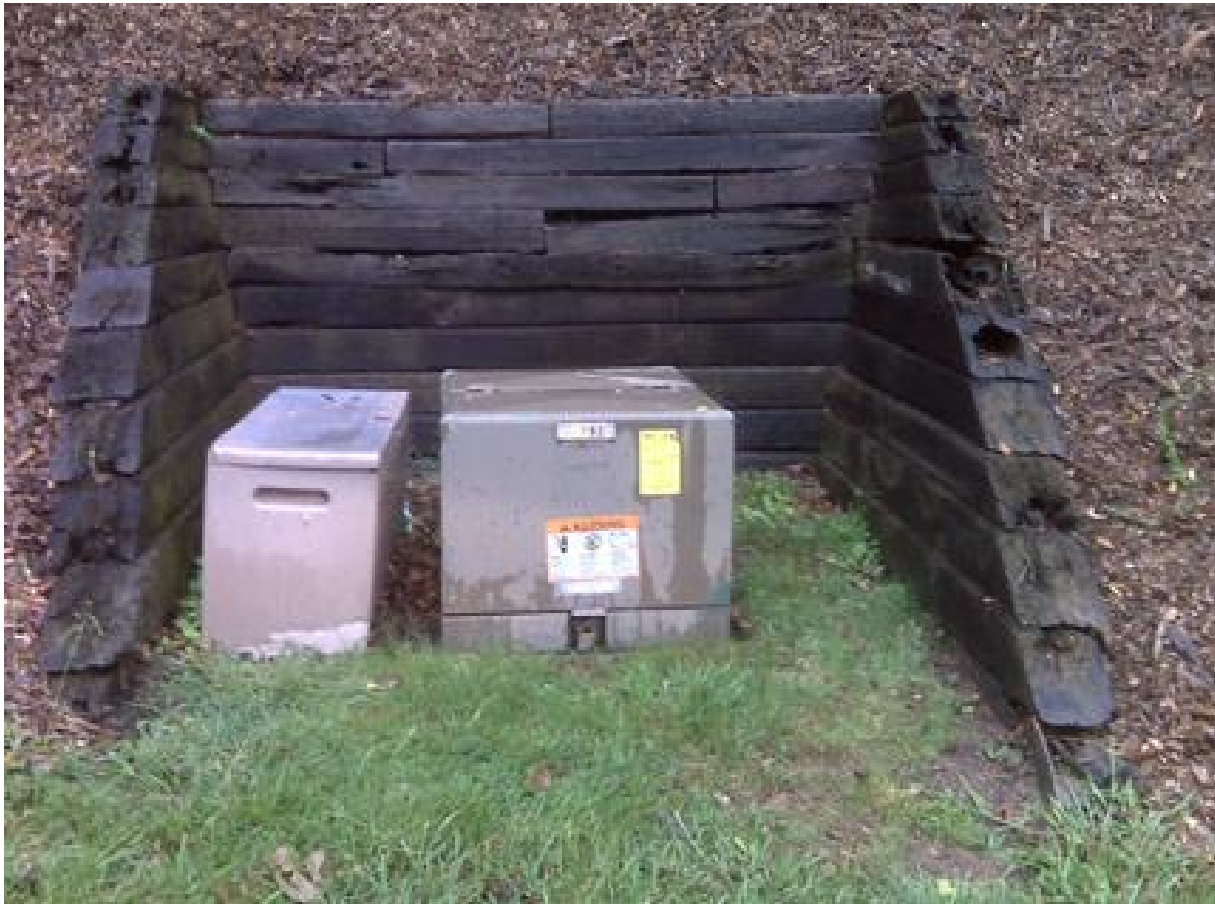
Some of the railroad ties in the Condominium’s retaining walls are already rotting. Here is the retaining wall that is in the poorest condition:

Figure 13.3
A Retaining Wall in Poor Condition

The building code requires that any retaining wall taller than four feet must be engineered. Six of the Condominium’s retaining walls are taller than four feet. An engineered wall typically uses interlocking blocks and a grid that extends several feet behind the wall. Paul Cremer, the head of Evergreen Landscaping, estimated that an engineered wall would cost about \$25 per square foot of surface area. We apply that estimated price to each retaining wall that exceeds four feet in
